Defect of the Month

Lead-Free Solder Paste Non-Coalescence

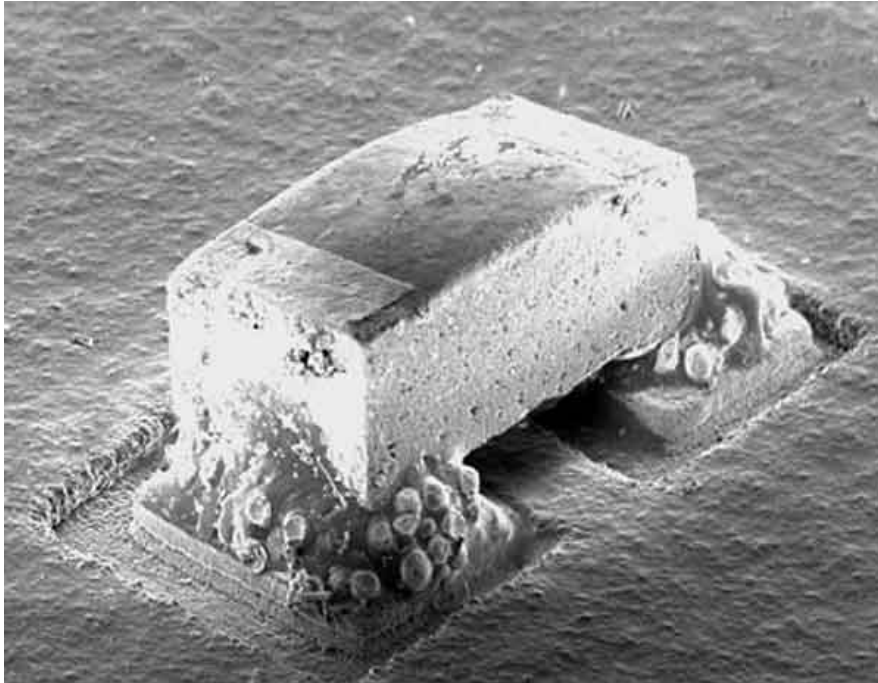
0201 chip component with lead-free solder paste that has not fully reflowed in air. This is a common fault on small paste deposits when people return to a traditional soak profile. Some solder pastes are far more tolerant than others, the resulting solder joint is sound but the balls have not fully reflowed in to the bulk of the solder joint.

This type of issue has been seen during 2003, 2004 on 0201 chip terminations and on 01005 chips in convection reflow but never in vapour phase soldering due to the inert atmosphere during the soldering stages of the process. Basically the small solder paste deposit is exposed to a long period at elevated temperature during a lead-free profile which reduces the performance of the flux in the paste. It is seen more with profiles that have a long pre-heat like a traditional profile. A profile which does not have long dwell prior to reflow is less affected.

Many paste suppliers have recommended the straight ramp profile but in the real world many users have not been able to achieve this with lead-free on existing ovens. In most cases the actual joint is satisfactory and only the outer surface shows this effect; however, most people would not accept this type of process defect.
